PHOTOGRAPHS
BEFORE REHABILITATION

RAINIER BREWERY
BOTTLING PLANT
(SEATTLE BREWING & MALTING CO)

5710 Airport Way S, Seattle, WA 98108

PHOTOGRAPHS
AFTER REHABILITATION

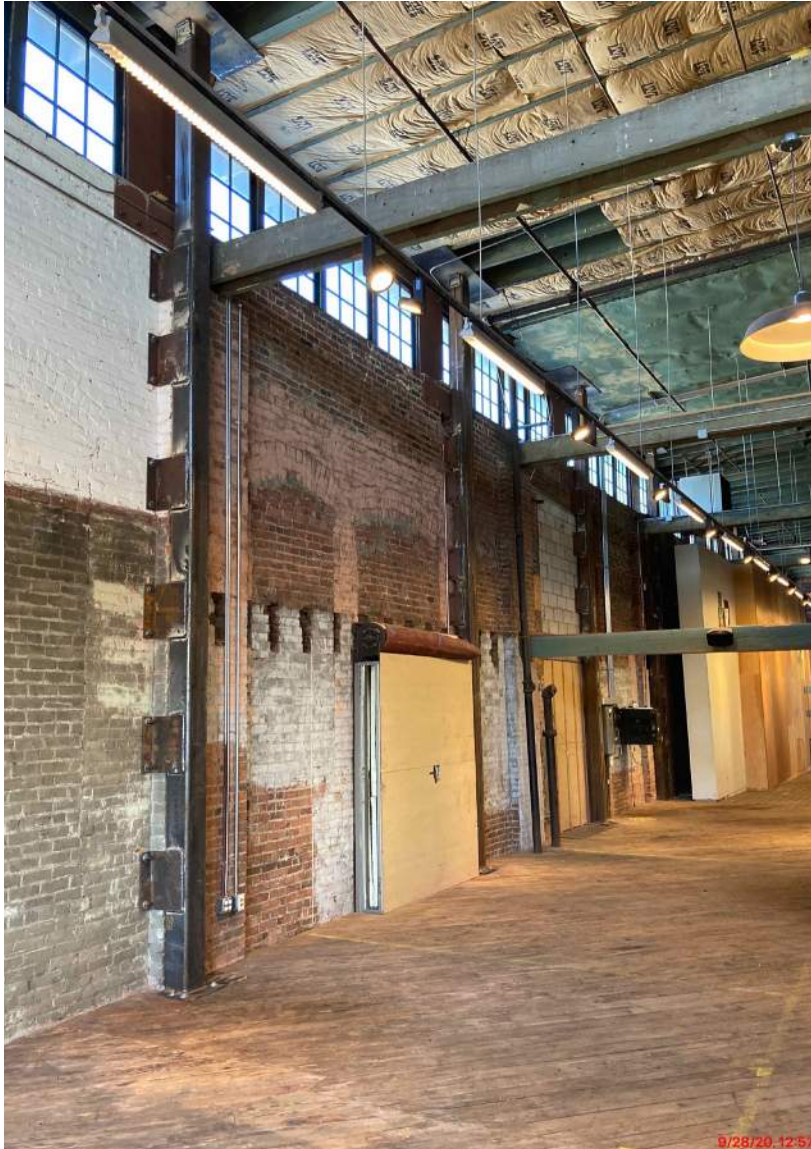
60

Painted wood ceiling;
painted brick walls;
gypsum board walls;
wood windows; wood
floor; wood beams and
joists; new metal strong-
backing; new steel plates
between clerestory
windows.

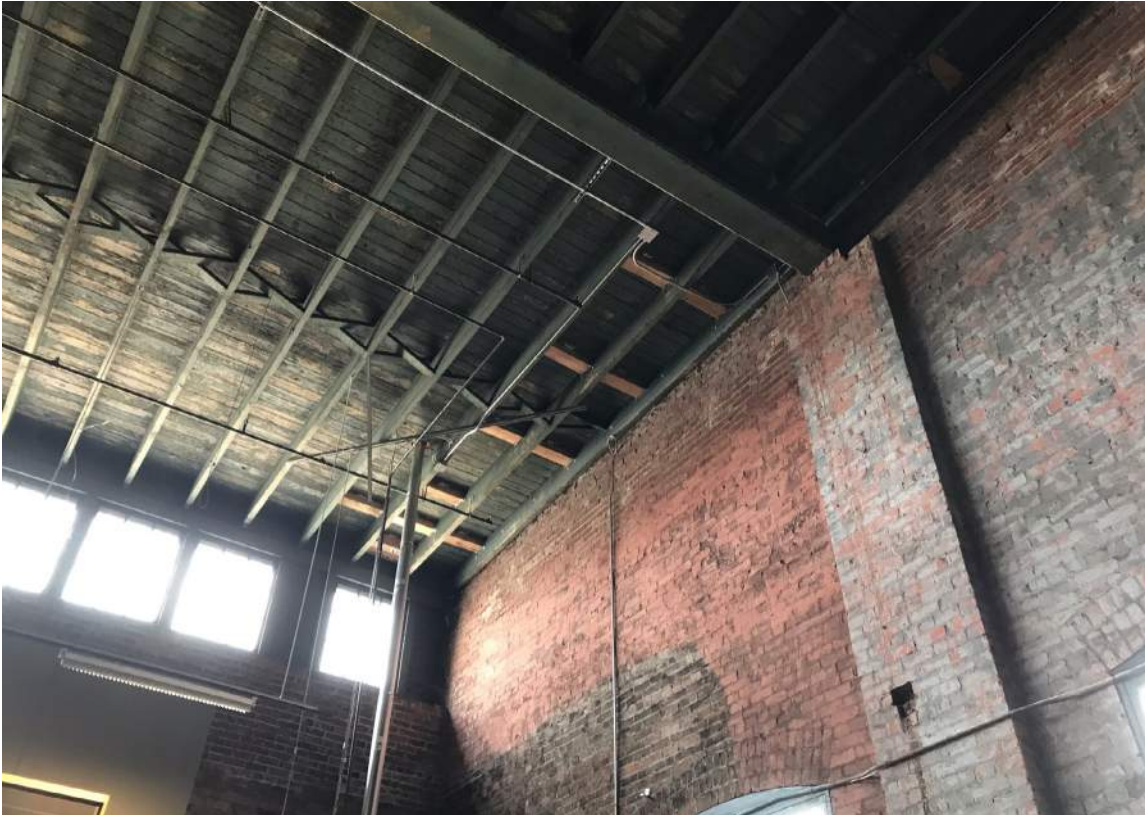
61

Painted wood ceiling;
painted brick walls;
gypsum board walls;
wood windows; wood
beams and joists; new
steel plates between
clerestory windows.

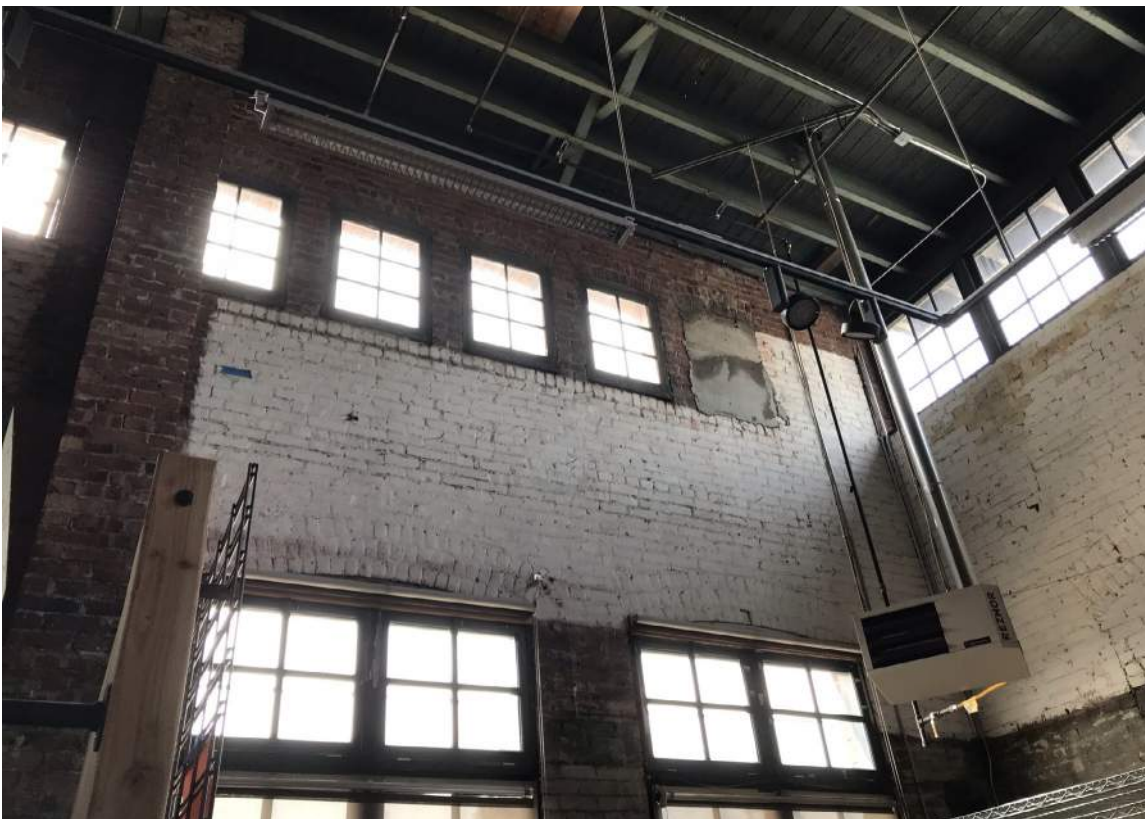
62

Painted wood ceiling;
painted brick walls; wood
windows; wood joists;
new concrete infill at
existing opening.

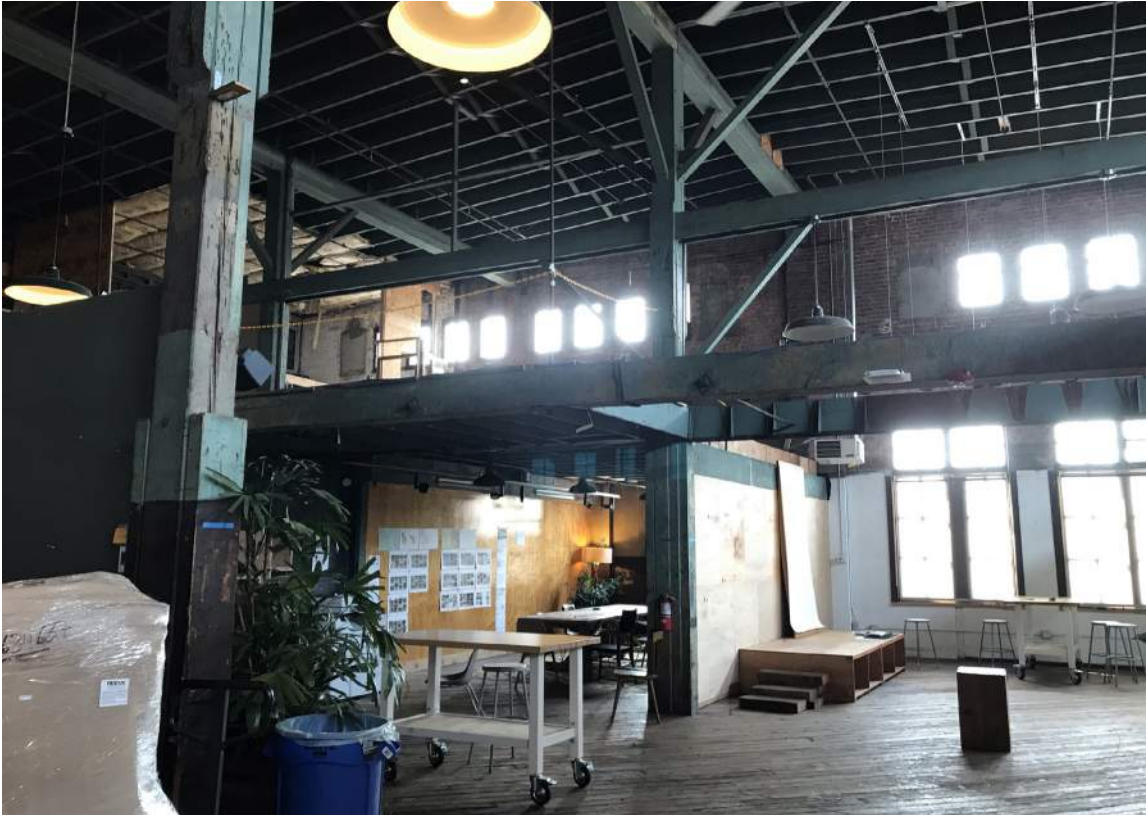
63

Painted wood ceiling; brick and gypsum board walls; wood windows; wood floor; wood beams, joists, and columns; new wood shear wall; new concrete infill at existing opening.
